## Compliant containment system outperforms in healthcare facility restoration

### Project 1 | situation: Extensive water damage to multiple patient rooms

### Project 2 | situation: Water damage in sterile operating room

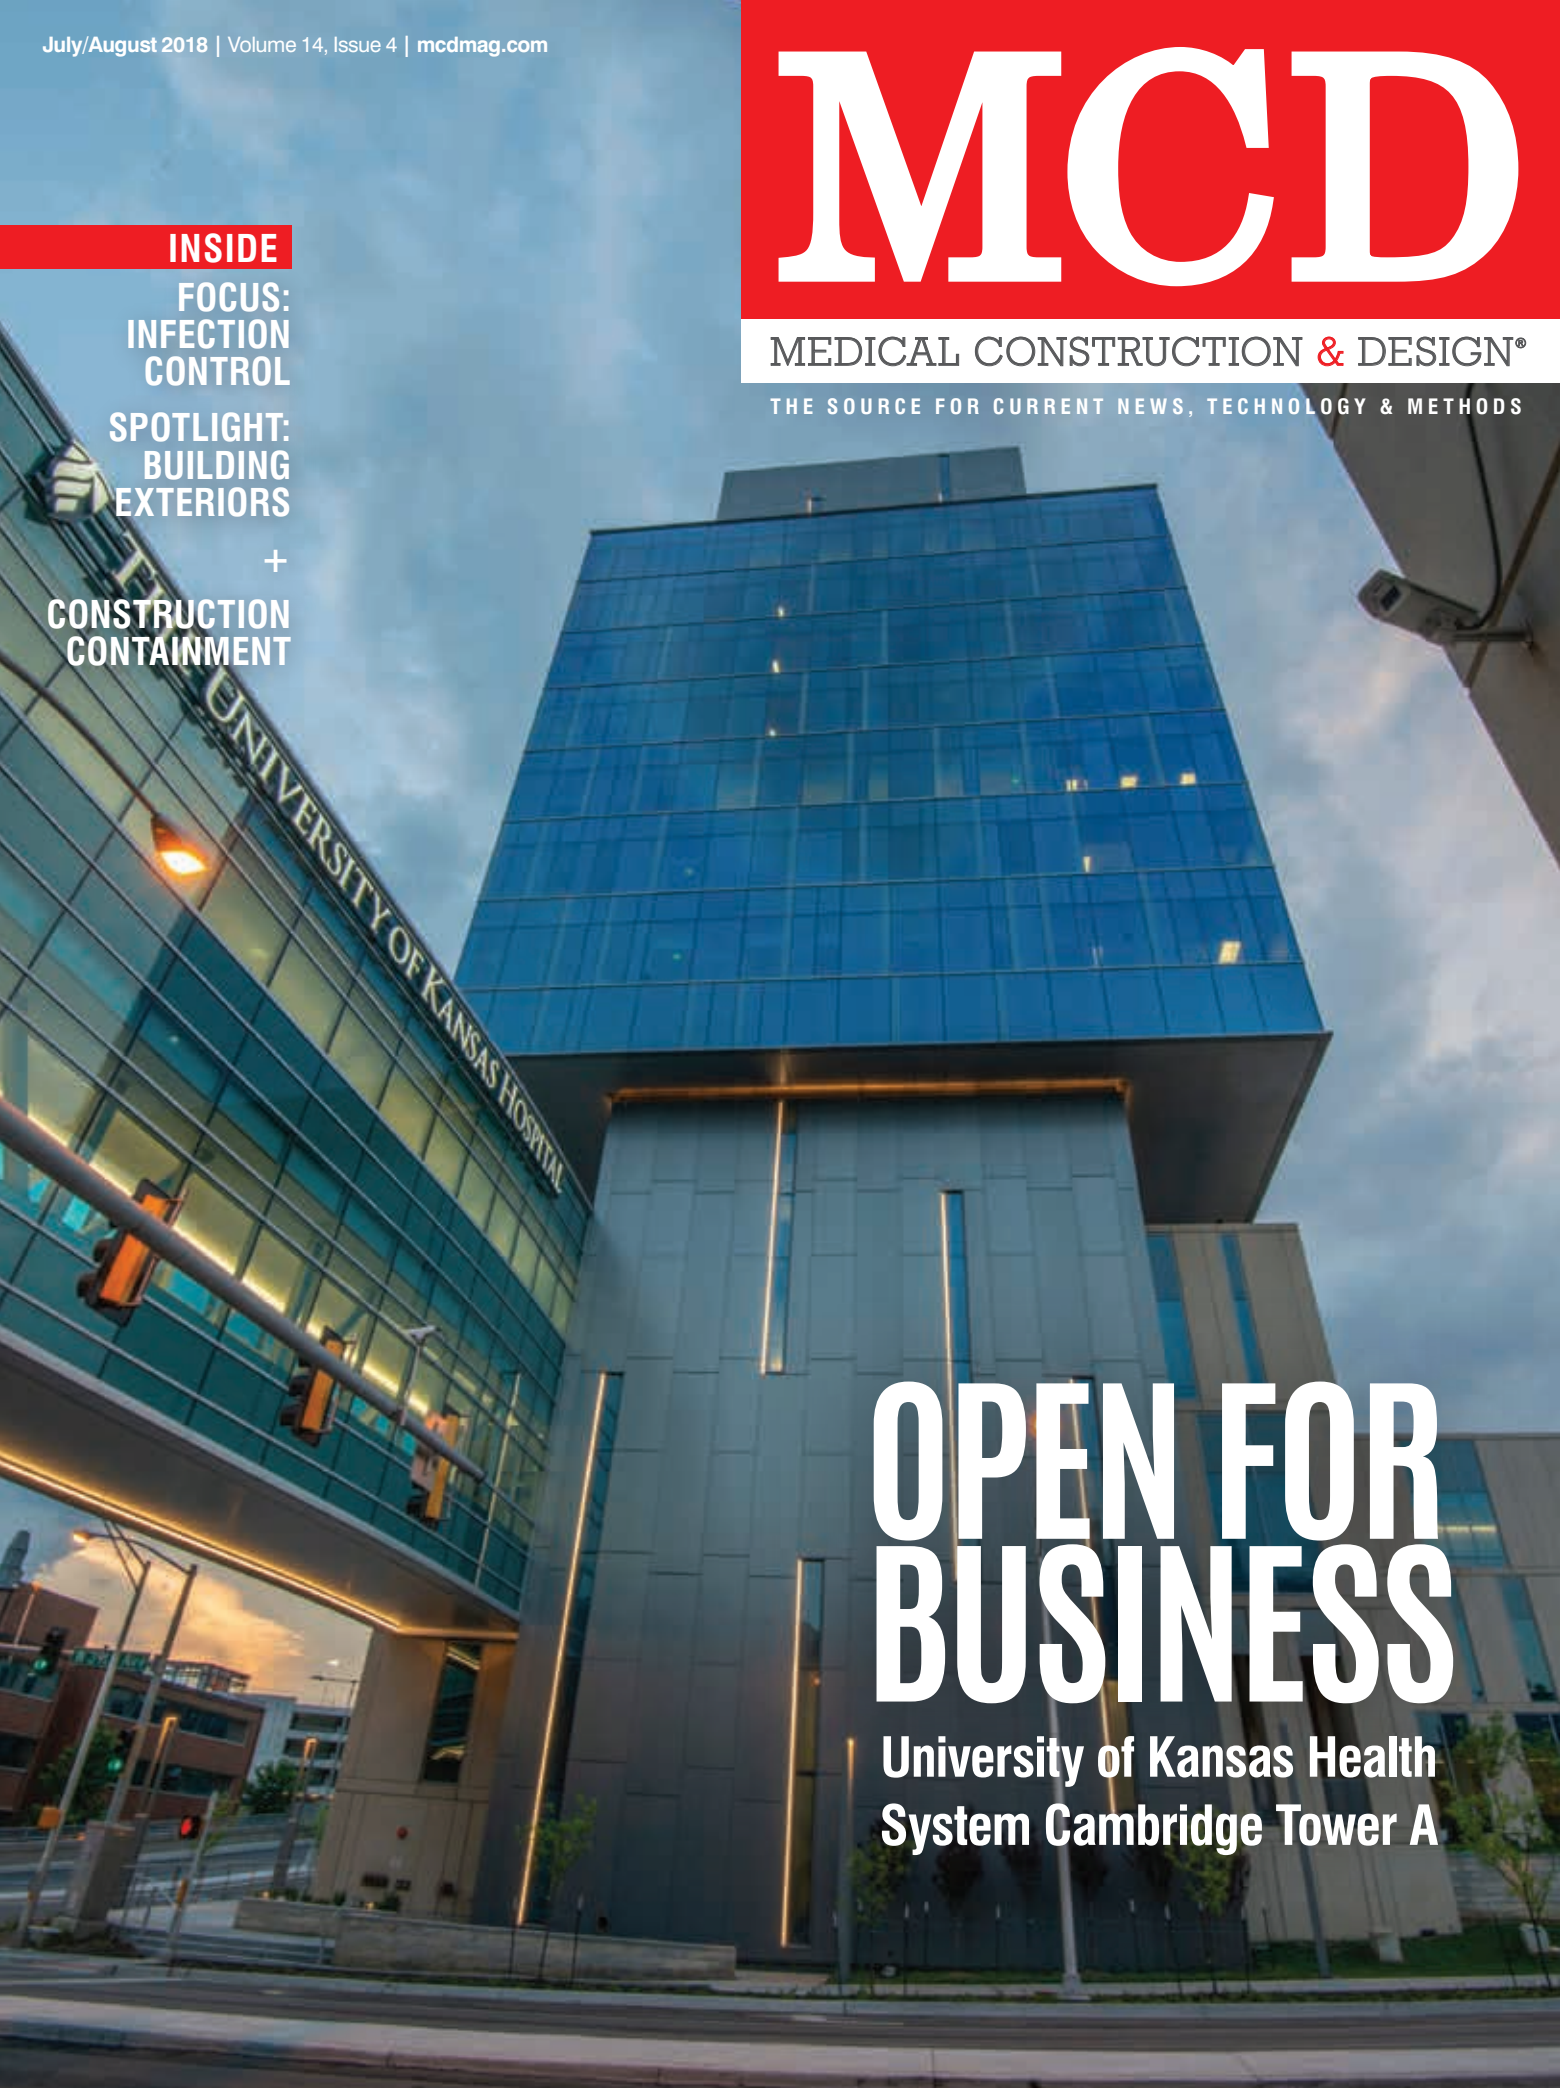
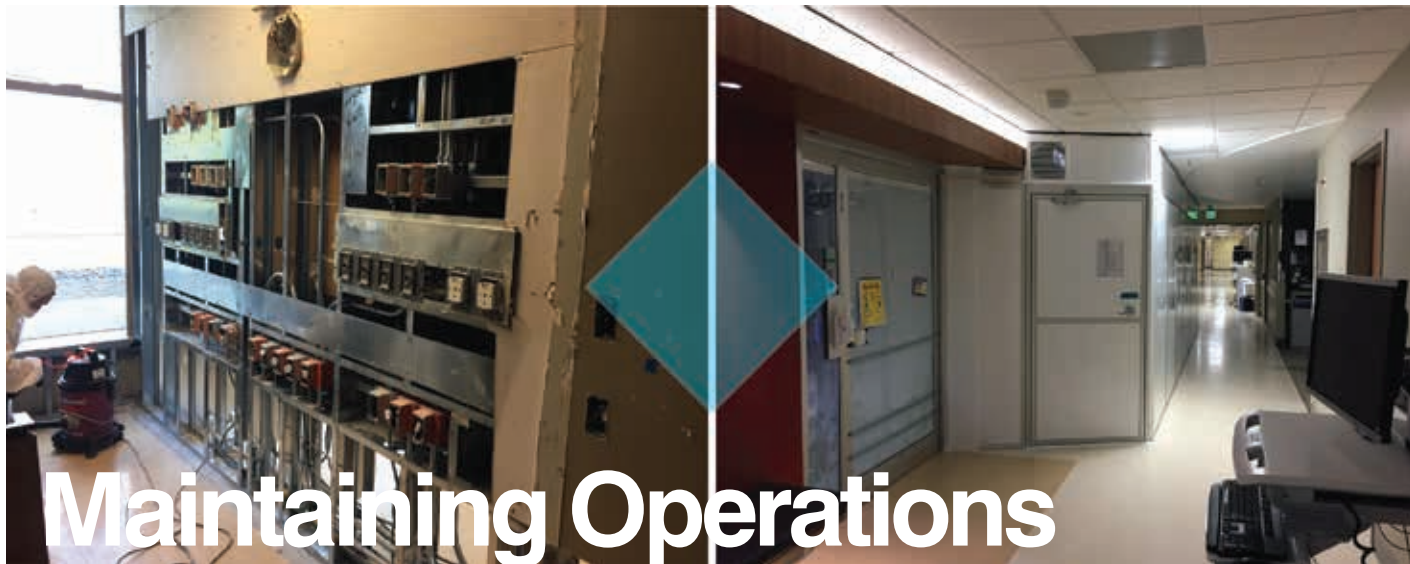
From top: Assessment and remediation of water damage being performed in a temporary STARC containment system. > Remediation and renovation performed with a STARC containment system and negative air.

temporary containment panels were erected to enable the crew to begin controlled removal of the damaged material, perform disinfection and begin renovation.

Patients were relocated and STARC Systems' ICRA Class IV compliant temporary containment panels were installed to isolate the affected space and establish and maintain negative air pressure required throughout the entire remediation and renovation process.
